County of Loudoun
Department of Planning

MEMORANDUM

SUBJECT: ZMAP 2008-0021 Kincora Village Center

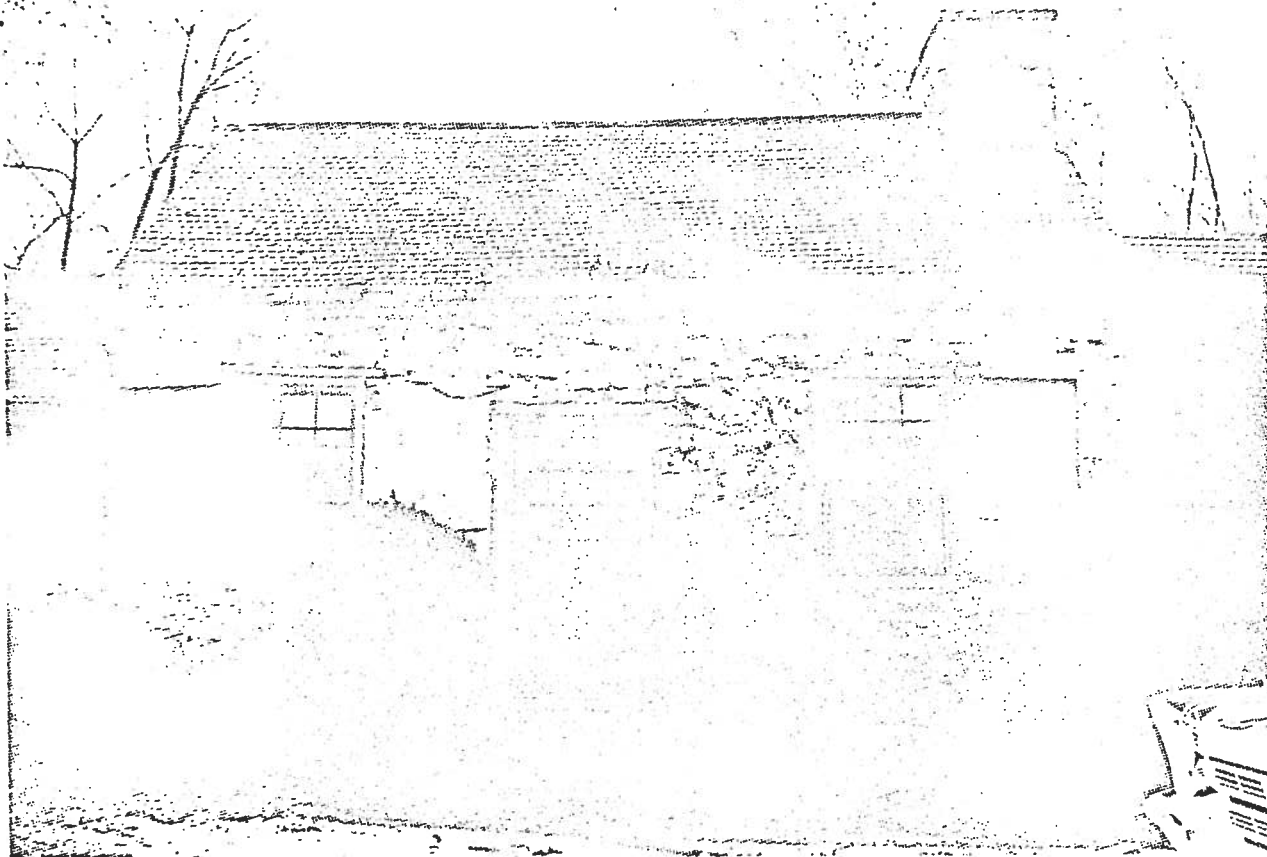
1. NAME			
COMMON: Broad Run Bridge and Toll House			
AND/OR HISTORIC: Broad Run Bridge and Toll House			
2. LOCATION			
STREET AND NUMBER:			
At intersection of Rt. 7, Rt. 28, and Broad Run.			
CITY OR TOWN:			
(Sterling vicinity)			
STATE:	CODE	COUNTY:	CODE
Virginia	45	Loudoun	107
3. PHOTO REFERENCE			
PHOTO CREDIT: Virginia Historic Landmarks Commission			
DATE OF PHOTO: 1969			
NEGATIVE FILED AT: Virginia Historic Landmarks Commission			
Richmond, Virginia			
4. IDENTIFICATION			
DESCRIBE VIEW, DIRECTION, ETC.			
View of Broad Run Bridge from the Northeast, with Toll House at far right.

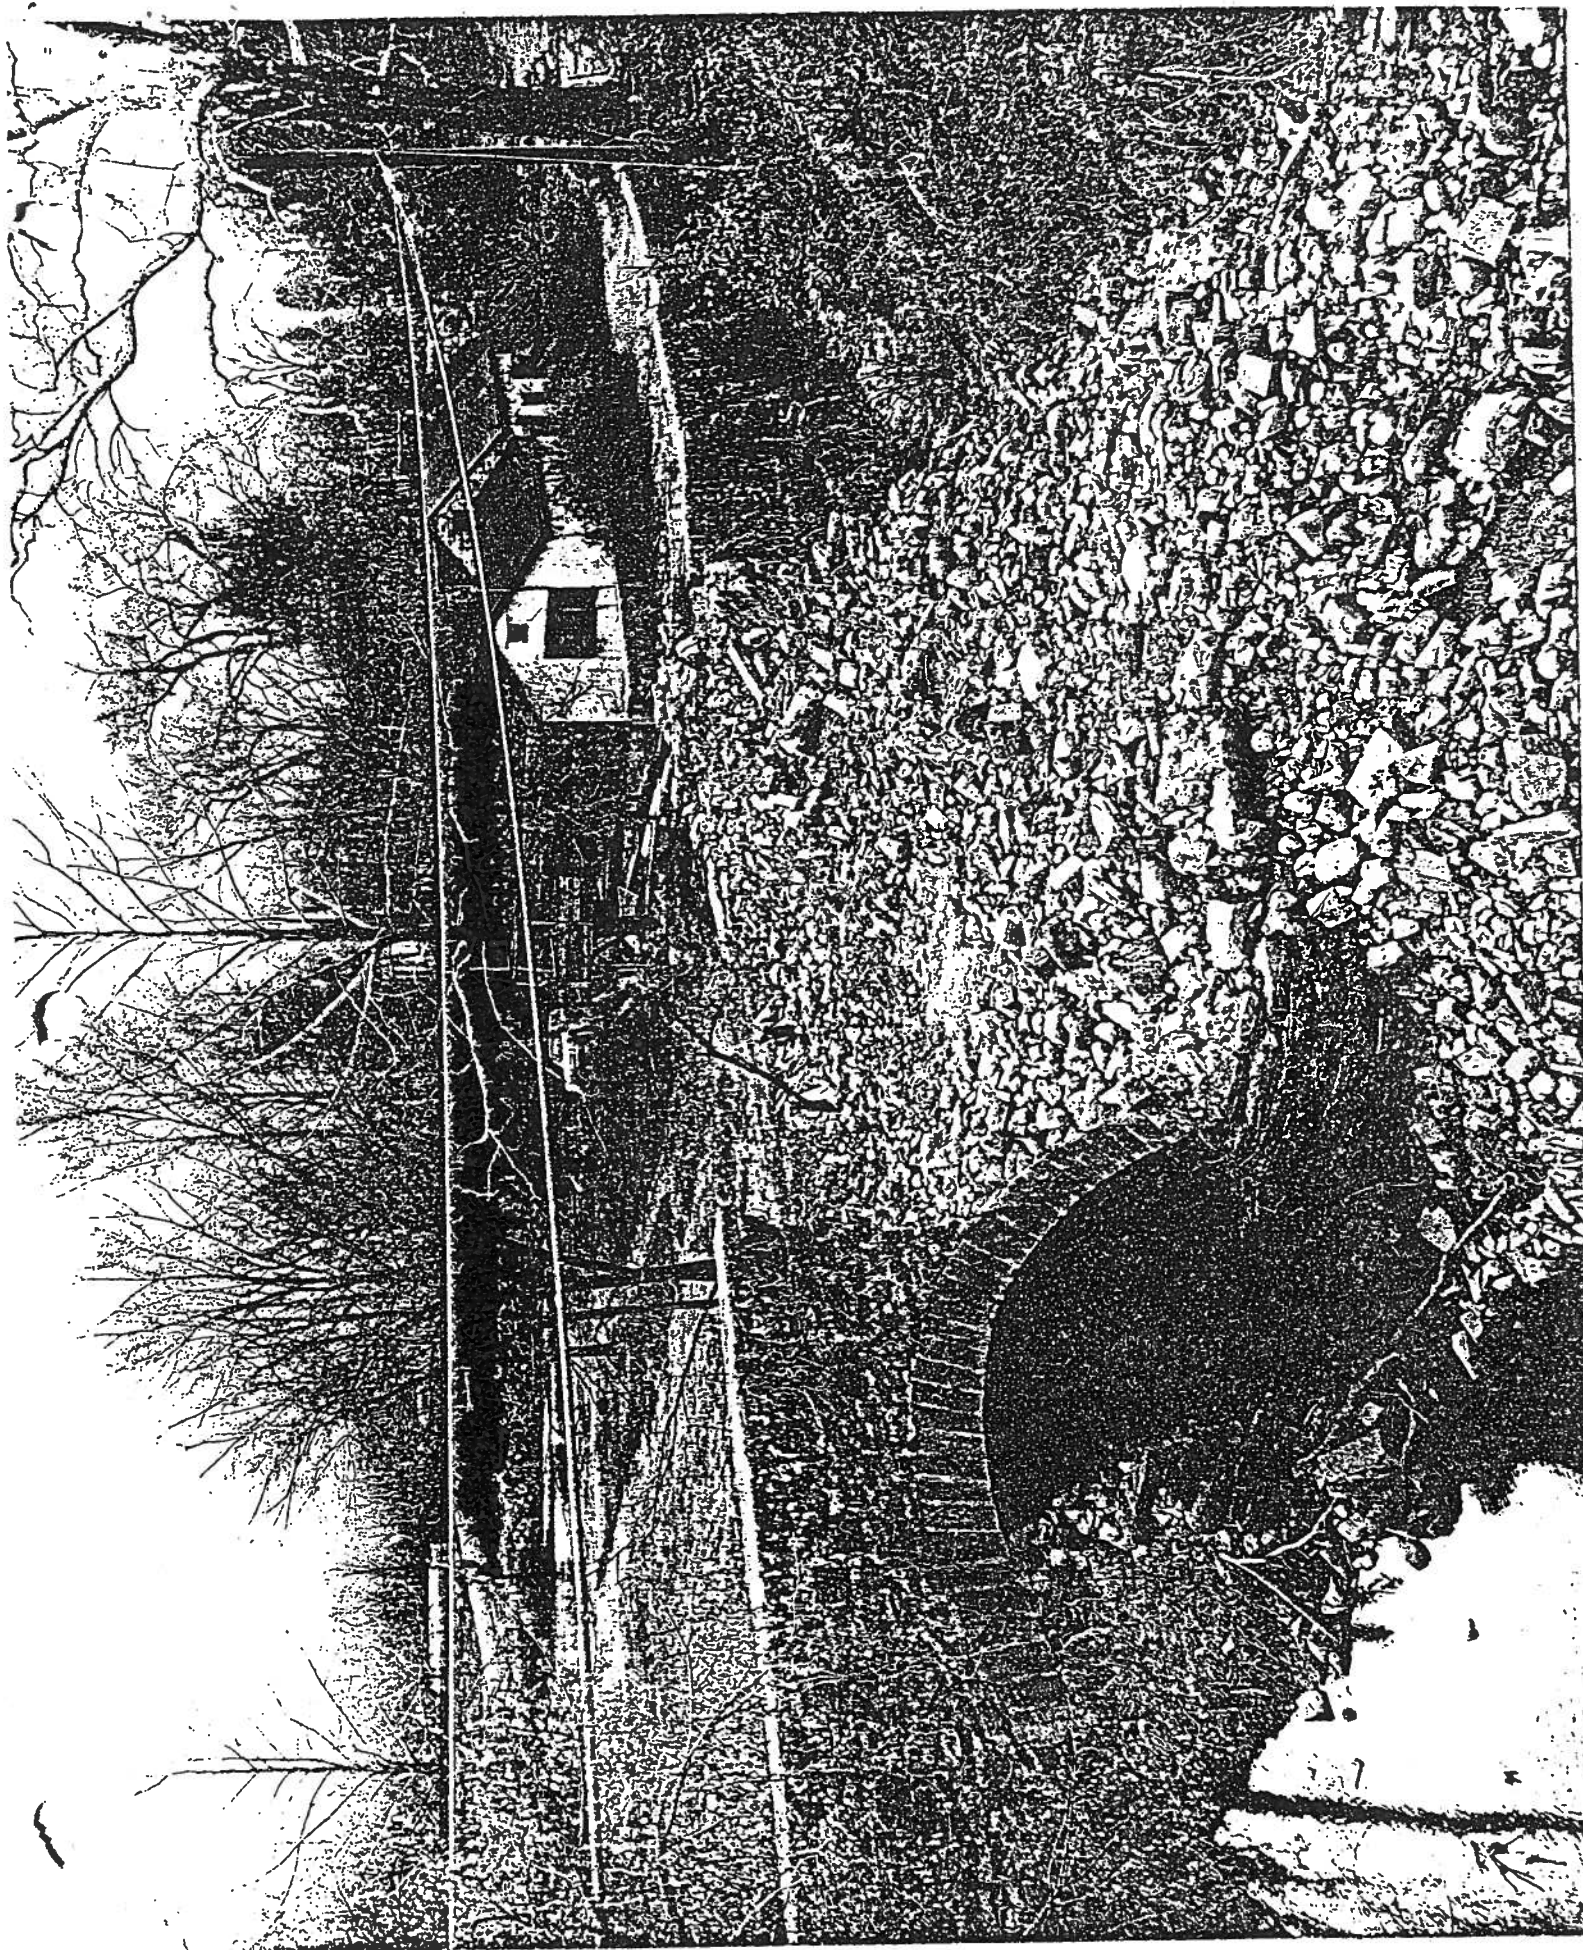
Copy of Summer 1972 View from Northeast.

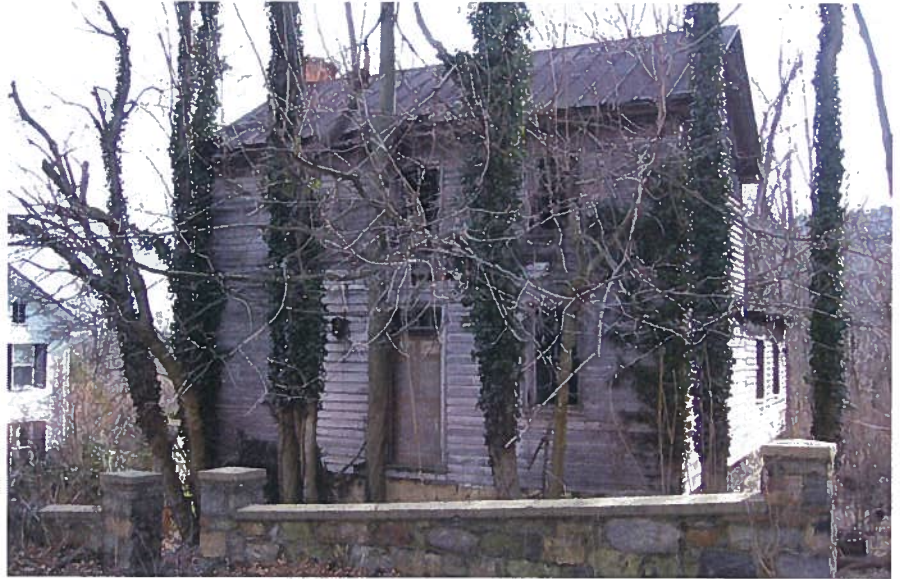
Left susceptible to invasive vegetation, vermin, and weather, this structure may soon be beyond rehabilitation.

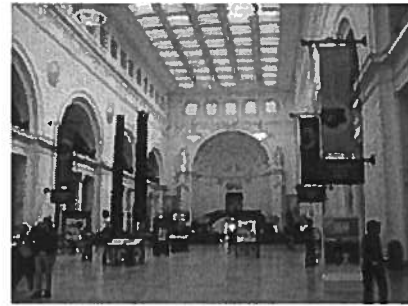
The scope of such studies includes the interior as well as exterior of the historic structure. This is the interior of the Stanley Field Hall, Field Museum, Chicago. Photo: McGuire Iglesias & Associates, Inc.

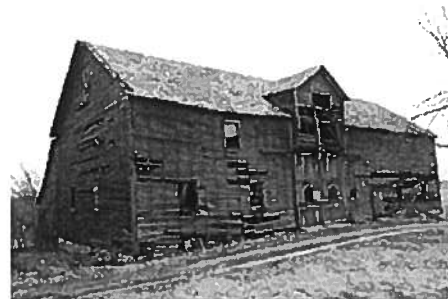
For small or simple projects, the project team may include only one or two specialists while complex projects may involve a large number of investigators and specialists. Evaluation of this barn may primarily involve an historian, an architectural

conservator, and a structural
engineer. Photo: Wiss Janney Elstner
Associates, Inc.

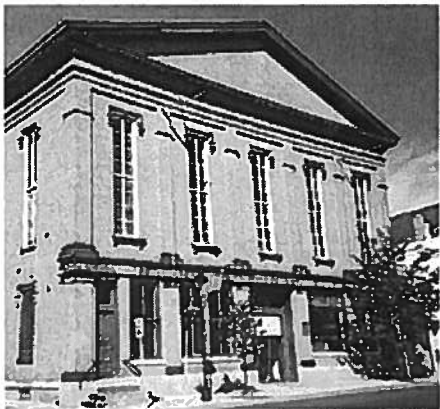
At the Hudson Opera House, a multi-arts center in Hudson, New York, the historic structure report was prepared incrementally. The first phase of the report focused on assessment and recommendations for

repair of the roofing, the most critical structural stabilization that will require removal of issue in preservation of the building. interior materials.
Photo: Gary Schiro.

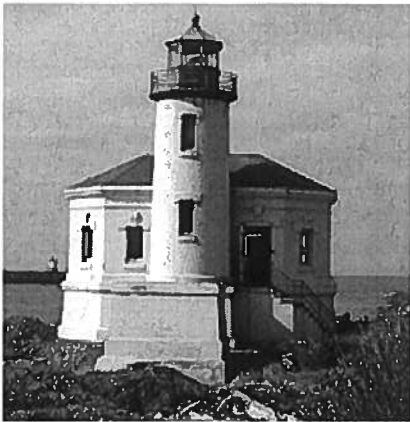
Numerous factors influence the cost of preparing a historic structure report including the level of significance, size, and complexity of the property; required treatment and use; existing condition; and the location and access to the structure. Historic structure reports were prepared for several small lighthouses along the Oregon coast, including the Coquille River Lighthouse, shown here. Photo: Wiss, Janney Elstner Associates, Inc.

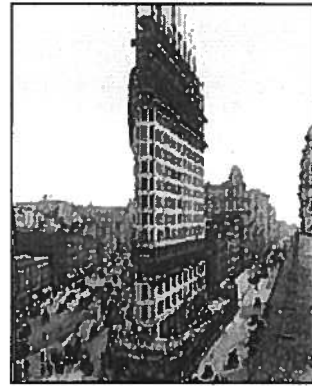
Historical research is directed toward gathering information on a structure's history, original construction and later modifications, occupancies, and uses over time.

Research may range from national repositories such as the Library of Congress to local collections or private family records. Old newspapers, architectural journals and even manufacturing trade catalogs can be surprising sources of historical accounts and illustrations. This circa 1902 photograph of New York's Flatiron Building is of the construction in progress; such photographs are useful in understanding building chronology as well as concealed conditions of as-built construction such as building framing. Photo: Library of Congress, LC-D401-14278.

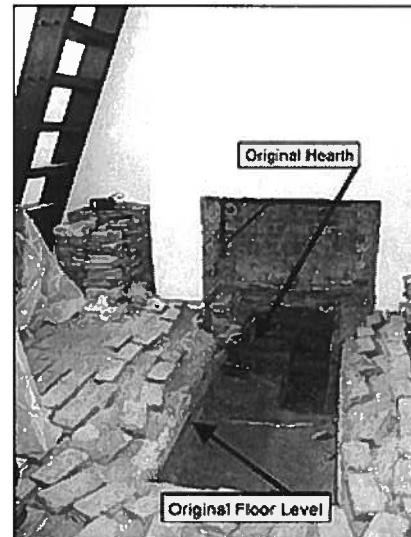
Archeological studies may be valuable in uncovering important evidence of changes to a historic structure. Following historical research and after several archeological soil probes, a decision was made to excavate an area in front of a mid-nineteenth century fireplace, revealing the original dirt floor and hearth undetected by earlier restoration efforts. Photo: NPS files.

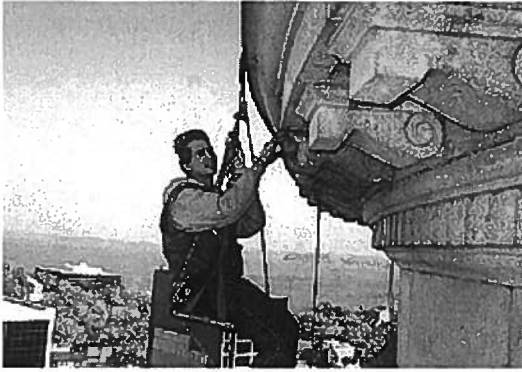
The use of special access methods may be necessary for close-up investigation of building elements. At the Wisconsin State Capitol, project architects and engineers used rappelling techniques. Photo: Wiss, Janney, Elstner Associates, Inc.

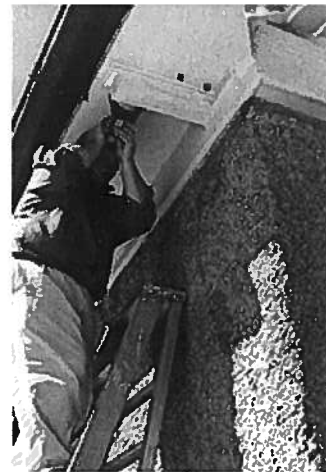
Paint studies may not only help establish the chronology of paints and paint colors used on a building but also may aid in the dating of existing architectural features. Examination of the paint layers on these modillions utilizing a hand-held microscope enabled an investigating team to confirm in the field which modillions were original and which were later replacements. Photo: NPS files.

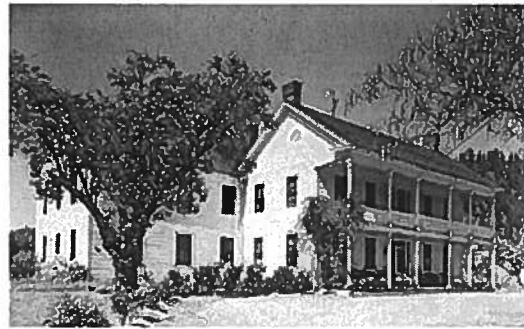
The treatment approach selected for a building usually is determined by the intended use of a property, funding prospects, and the findings of an investigation. The Wolf Creek Inn, operated by the Oregon Parks and Recreation Department, is among the most intact and oldest active traveler's inns in Oregon. The historic structure report outlined a rehabilitation treatment which included such work recommendations as repairs to specific historic fabric, landscape restoration and site improvements, and upgrading of the building's mechanical and electrical systems. Photo: Historic American Building Survey, 1934.

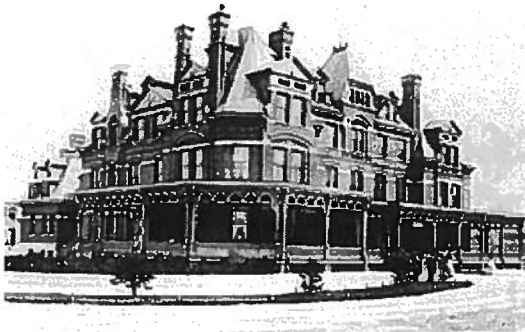
The historic structure report for the Hotel Florence, shown here in 1886, provided a basis for stabilization and repair work which has been completed. Initial phases of work addressed preservation of the building envelope, structural repairs, and limited mechanical and electrical improvements. The report also provided recommendations for future rehabilitation work that will be implemented in phases as funding becomes available. Photo: Historic American Buildings Survey.

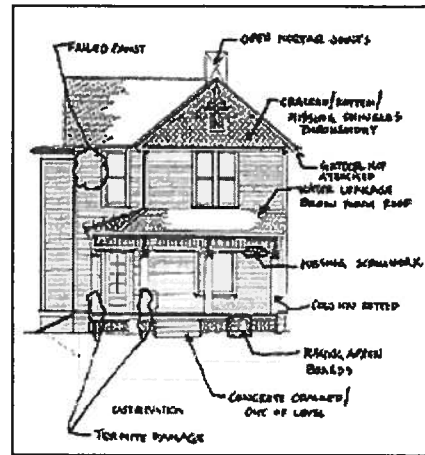
This is one of the measured drawings for the Noland House (see above, left). Drawing: Bahr, Vermeer & Haecker, Architects Ltd.
